Manhole Inspection Summary

Manhole # S21M__040MH

Insp Date: **2/20/08 2:54 PM**

Location Address: **525 s monroe st**

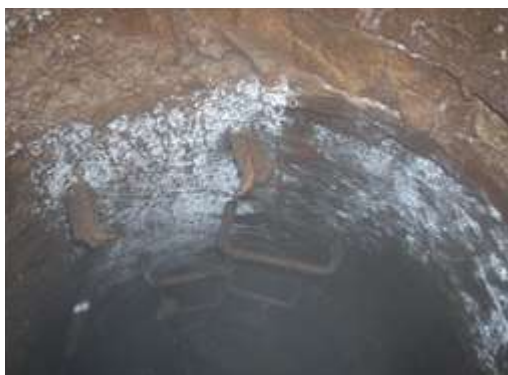
Defect 4

Count: **7** Missing: **1** ☒ **Corroded**

corroded steps

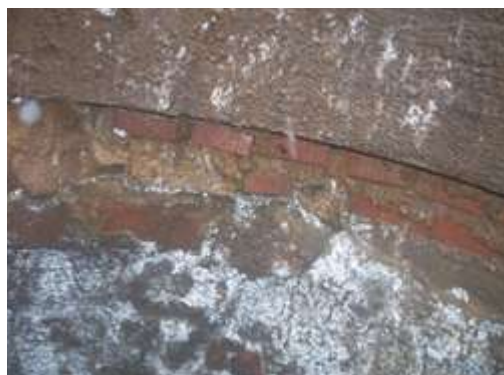
Defect 3

Condition: ☐ Sound ☐ Cracked ☐ Root Intrusion ☐ Loose Brick ☒ **Deteriorated**

deteriorated chimney

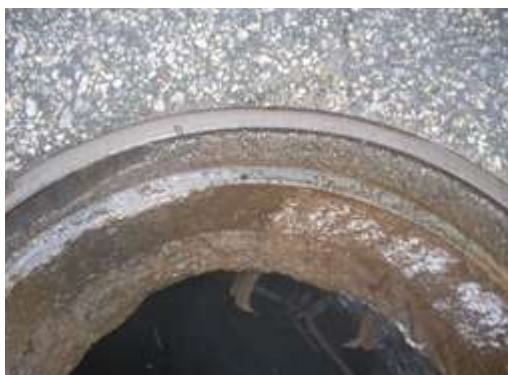
Defect 2

Offset: **2** (in.)

frame offset

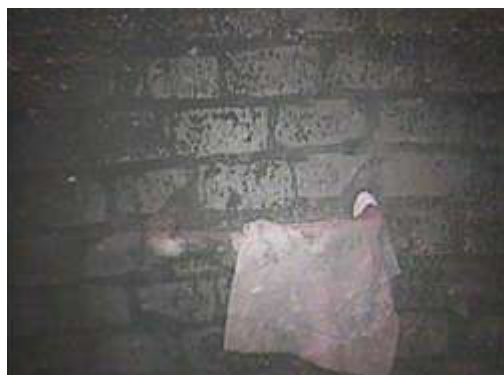
Defect 1

☒ **Evidence Of Surcharge** Depth: **4** (ft.) ☐ Active Surcharge Present

surcharge evidence on the step

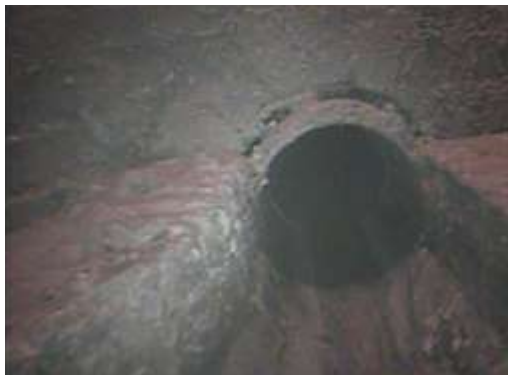
Defect 5

Condition: ☐ Sound ☐ Cracked ☐ Root Intrusion ☐ Deteriorated ☐ Leaks ☒ **Debris**

bench and channel debris

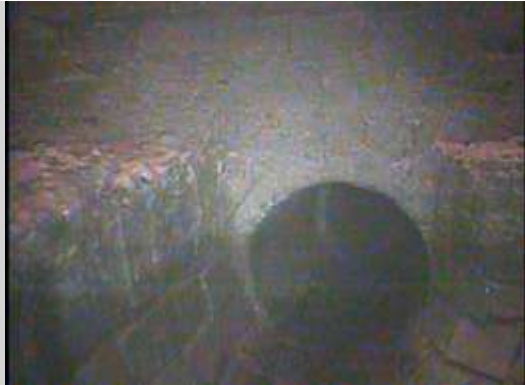
12 O'Clock Outflow

Pipe Height: **10.8** (in.) Rod and Bar (Angled)
Pipe Material: **Clay** ☐ Pipe Lined
Invert Depth: **12.41** (ft.) Flow Characteristics: **Slow**
Deposits: ☒ None ☐ Mud ☐ Sludge ☐ Debris ☐ Grease
Silt Depth: **0** (in.) Deposits Extent:
Infiltration: **None** Pipe Seal Cond: **Sound**

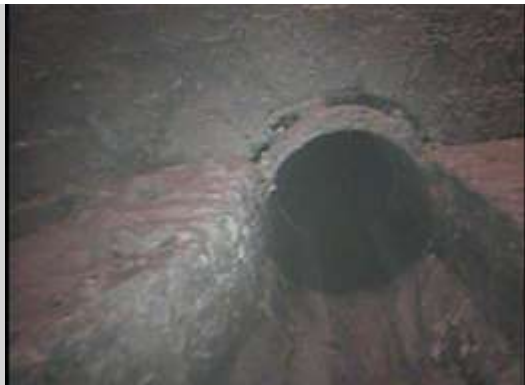
3 O'Clock Inflow

Pipe Height: **8.4** (in.) Rod and Bar (Angled)
Pipe Material: **Clay** ☐ Pipe Lined
Invert Depth: **11.94** (ft.) Flow Characteristics: **Slow**
Deposits: ☒ None ☐ Mud ☐ Sludge ☐ Debris ☐ Grease
Silt Depth: **0** (in.) Deposits Extent:
Infiltration: **None** Pipe Seal Cond: **Sound**

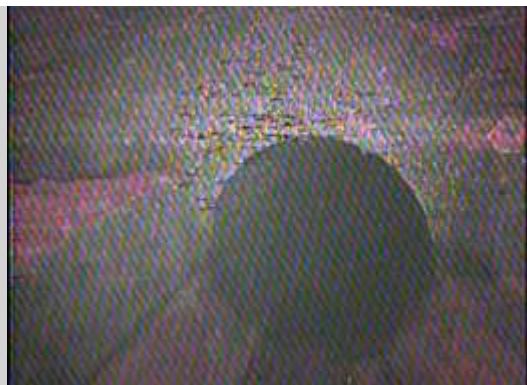
6 O'Clock Inflow

Pipe Height: **10.8** (in.) Rod and Bar (Angled)

Pipe Material: **Clay** ☐ Pipe Lined

Invert Depth: **12.16** (ft.) Flow Characteristics: **Slow**

Deposits: ☒ None ☐ Mud ☐ Sludge ☐ Debris ☐ Grease

Infiltration: **None** Pipe Seal Cond: **Sound**
